Cape Palliser – storm resilience

EcoReef® performance during May 2025 red level storm event

Project Cape Palliser

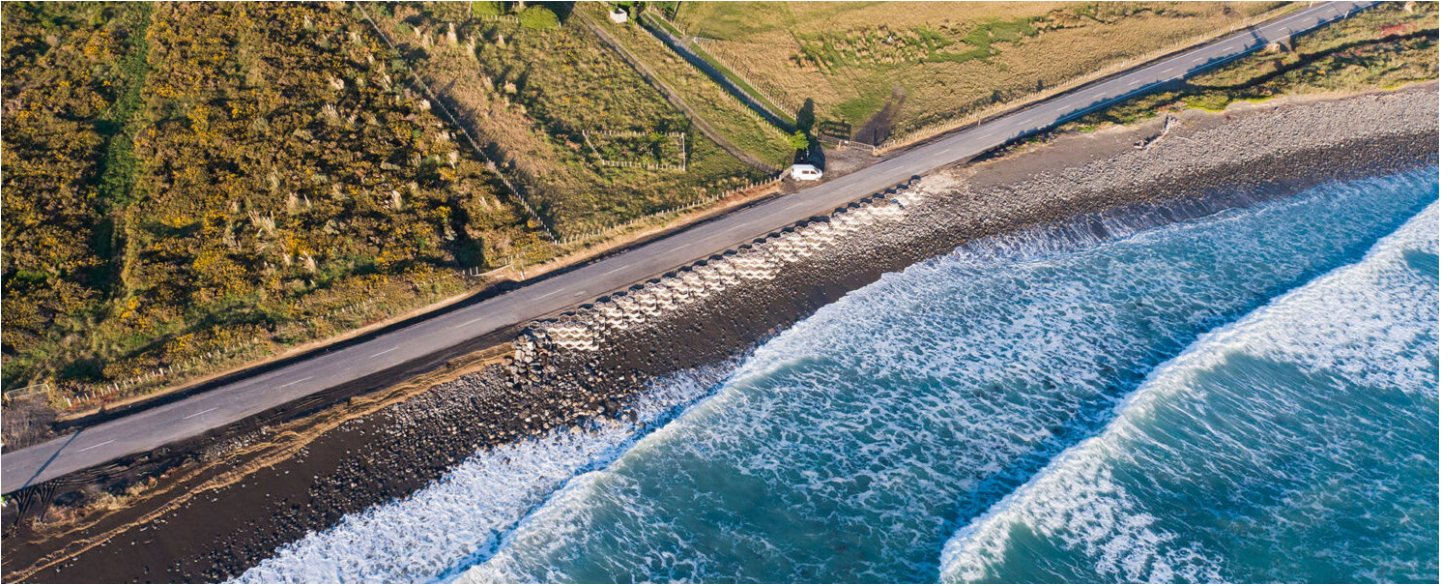
Despite the severity of the storm, the EcoReef® structure performed exceptionally well. Notably:

- **Structural Integrity Maintained:** Despite the impact of large rocks during the event, all EcoReef® modules remained securely in place, with no signs of damage or compromise to their structural soundness.

- **Minimal Fill Loss:** Although the site has never received maintenance, only minimal loss of fill has occurred, even during this recent high-energy event. Though it is important to note that the EcoReef® modules do not rely on fill for their structural performance.

- **Integrity of Road Preserved:** The structure effectively shielded the road, preventing damage and preserving its integrity.
- **Validation of Early Investment:** Not only did the EcoReef® structure perform well, but its resilience during this extreme weather event also reinforced the foresight and commitment shown by South Wairarapa District Council in supporting an untried and innovative system over three years ago.

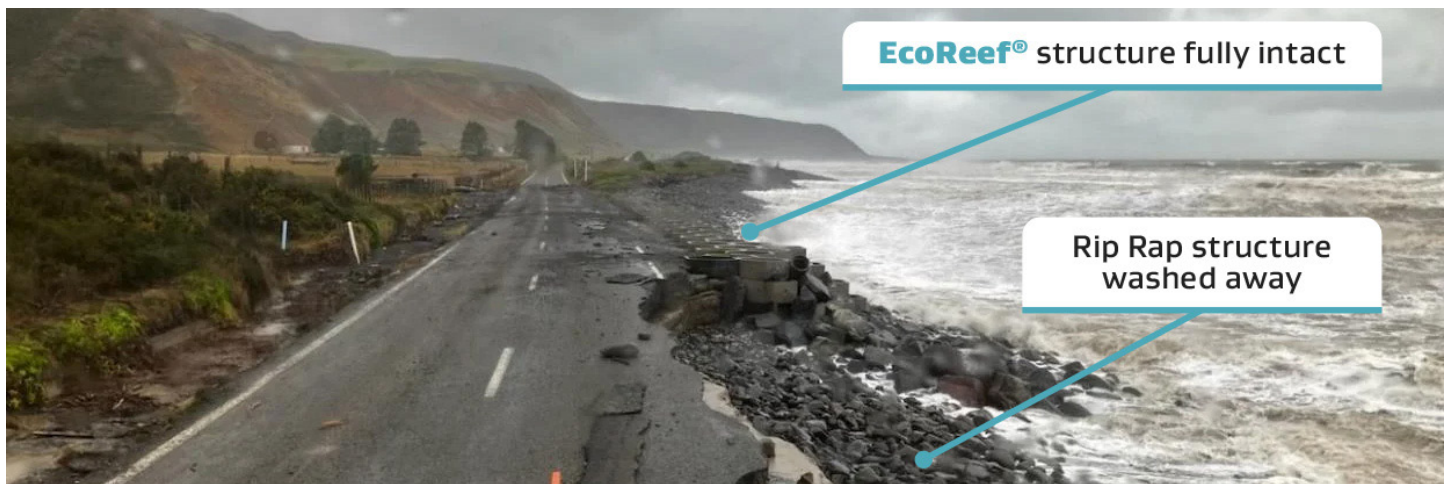
EcoReef® structure fully intact

Rip Rap structure washed away

This trial provided a direct comparison between the EcoReef® system and traditional riprap, installed at either end of the structure and exposed to identical storm conditions. During a red-alert storm event, the riprap was completely washed away, leaving the adjacent road exposed and unprotected. In contrast, the EcoReef® structure demonstrated superior performance – effectively shielding the roading infrastructure, which remained intact despite sea debris being scattered across its surface.
